## **Instrumentation of the Cervical Spine by Fixing Sensors on the Anterior Part of the Vertebra**

P. Potier, J. P. Lassau

*In order to obtain data on the behavior of the cervical spine, sensors were fitted, in boxes, to the anterior parts of three vertebrae (C2, C5, T1). This instrumentation was required for a series of 19 low-speed, rear-end impact tests carried out on 3 unembalmed cadavers. This instrumentation required a fine dissection of the anterior part of the neck, taking care to avoid lesion of the different anatomical structures. The sensors included in the box were 1) one angular velocity sensor Y axis, 2) one linear accelerometer X axis, 3) one linear accelerometer Z axis, and 4) X-ray photographs were used to check the positioning of the sensors before and after fixing the sensor box. The cervical sensor screws were checked manually between the tests. In conclusion, this methodology allowed data to be obtained on each of the three cervical vertebrae instrumented without any damage to the mechanical coupling throughout the tests.*

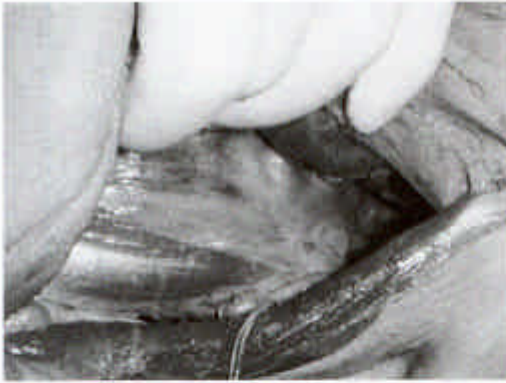
Figure 5. Anterior face of cervical spine, lower view

The aim of the technique is to minimize ligament and muscle lesion. To do this, the following steps are carried out on both sides of the neck. First an incision of the skin and platysma muscles from the sternoclavicle joint to the temporo-mandibule joint was made. This was followed by the dissection of the anterior edge and deep face of the sternocleidomastoid muscle. The transverse cervical vein was then clamped and the dissection of the omohyoid and sternohyoid muscles and section of the omohyoid muscle was conducted. Similarly, the anterior jugular vein was clamped and dissection of the internal jugular vein was conducted. This was followed by the dissection clamping and section of the internal and external carotid artery as high as possible. At the bottom of the dissected area, clamping and section of the common carotid artery was carried out. Dissection of the anterior face of the cervical spine from C1 to C7 and the upper part of the thoracic spine to T2. By doing this, the anterior face is totally free providing the space necessary to place the sensor boxes.

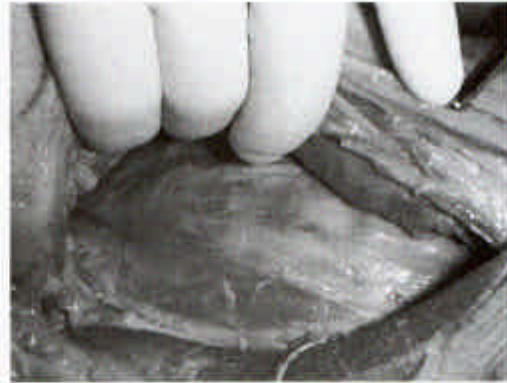
Figure 6. Anterior face of cervical spine, upper view

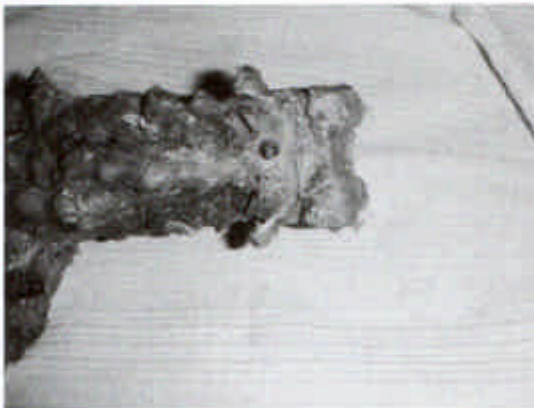
Figure 7. Screw on the base of the odontoid process

First of all, the positioning of the C2 sensor box is defined using the finger to find the anterior tubercle on C1. In order to position the screw-driver, the mouth is opened and the posterior wall of the oropharynx is dissected. The C2 sensor box is screwed onto the base of the odontoid process under the anterior tubercle of C1 after an X-ray check on the position and axes.

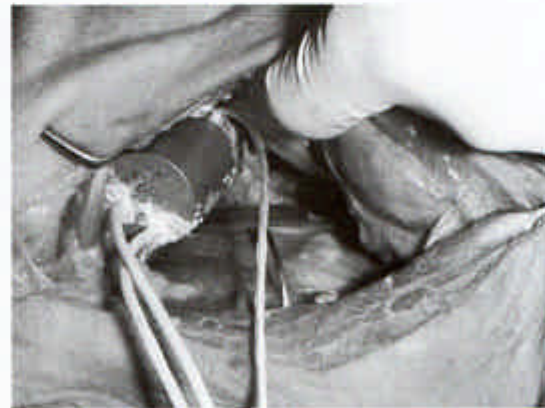
Figure 8. Sensor box screwed on C2

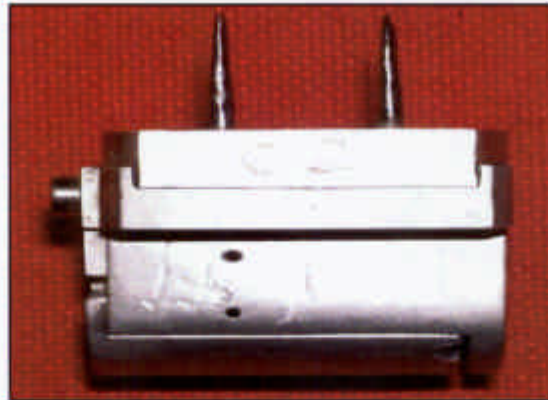
Figure 9. Pins on C2 mounting plate

Since only one screw was used, the box was fitted with two pins which prevented rotation when inserted in the vertebra.

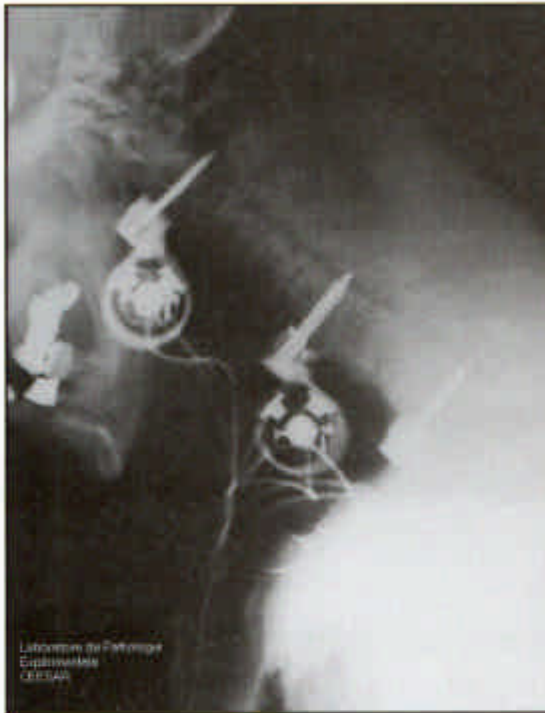
Figure 12. X-ray side view of the cervical spine equipped with three sensor boxes

When the three sensor boxes are fixed in position, the compatibility of the sensors boxes (particularly when flexion occurs) is checked using X-rays.

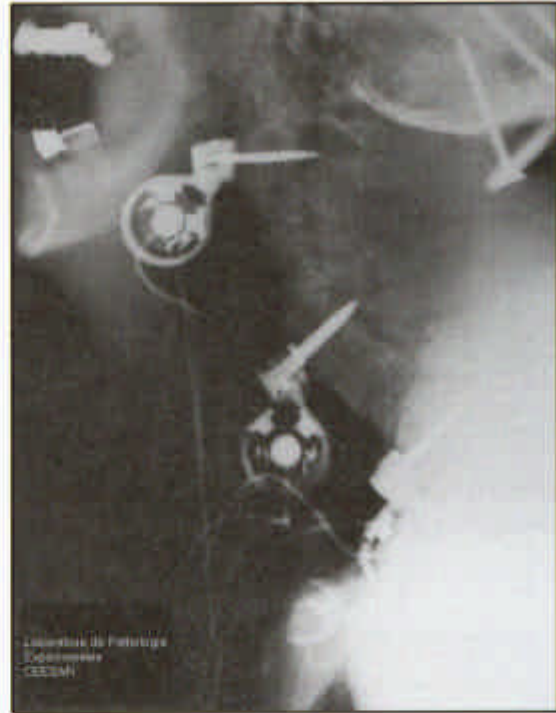
Figure 13. X-ray side view of the cervical spine equipped with three sensor boxes

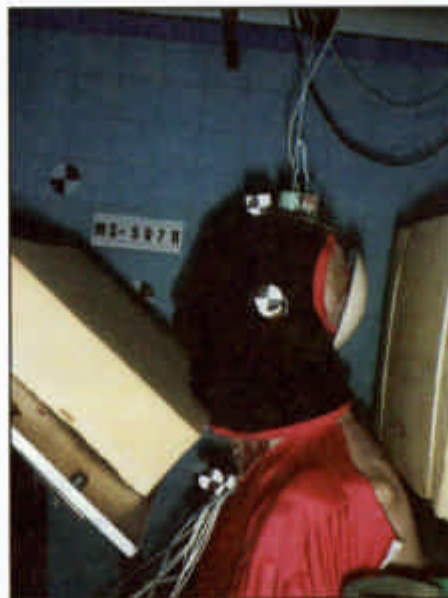
Figure 14. PMHS in position before test with foam in front of the head

- 1) The sled was equipped with a plate covered with foam to limit the neck flexion when braking. In doing this, no contact occurs between the sensor boxes and the lower vertebra.
- 2) After each test, the sensor boxes coupling with the vertebrae was checked for any relative motion. The screws were checked as well. That is another reason why the skin was not stitched.
